# Roof Inspection Report

John Doe  
XXXX SW 36 Avenue  
West Park, Florida 33023

# Roof Condition Certification Form

APPLICANT / INSURED NAME John Doe  
APPLICATION / POLICY #  
ADDRESS INSPECTED XXXX SW 36 Avenue , West Park, Florida, 33023  
DATE OF INSPECTION Jan 21, 2011

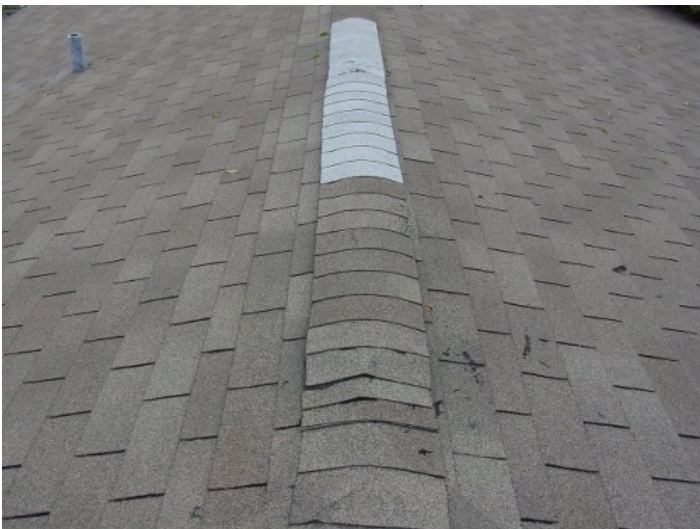
**Ridge vent - some shingles replaced**

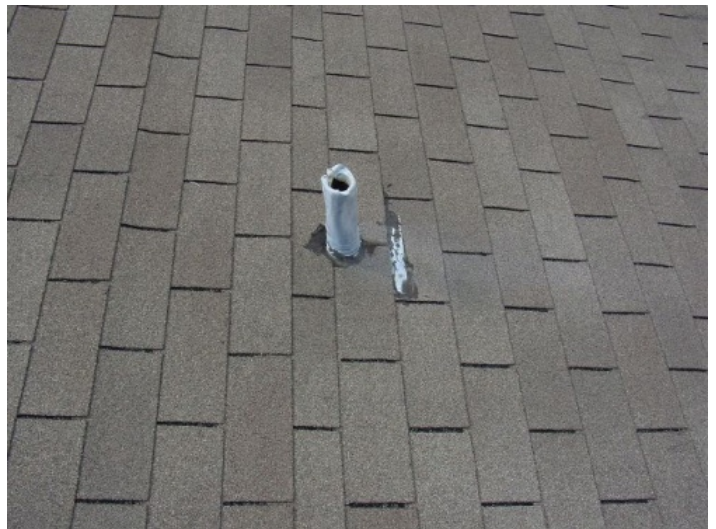
**Roof penetrations looked good**

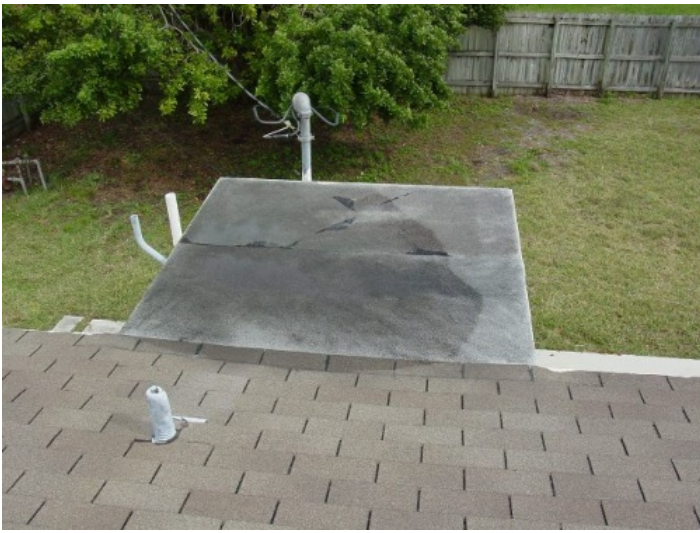
**Flat roof over the utility room looked good**

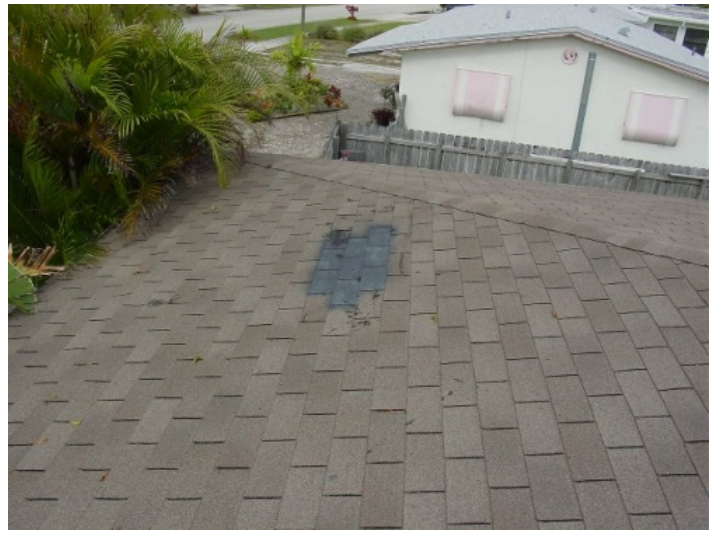
**Hip roof - some shingle replaced on the front left side**
