# Roof Inspection Report

John Doe  
XXXX SW 36 Avenue  
West Park, Florida 33023

# Roof Condition Certification Form

APPLICANT / INSURED NAME John Doe  
APPLICATION / POLICY #  
ADDRESS INSPECTED XXXX SW 36 Avenue , West Park, Florida, 33023  
DATE OF INSPECTION Jan 21, 2011

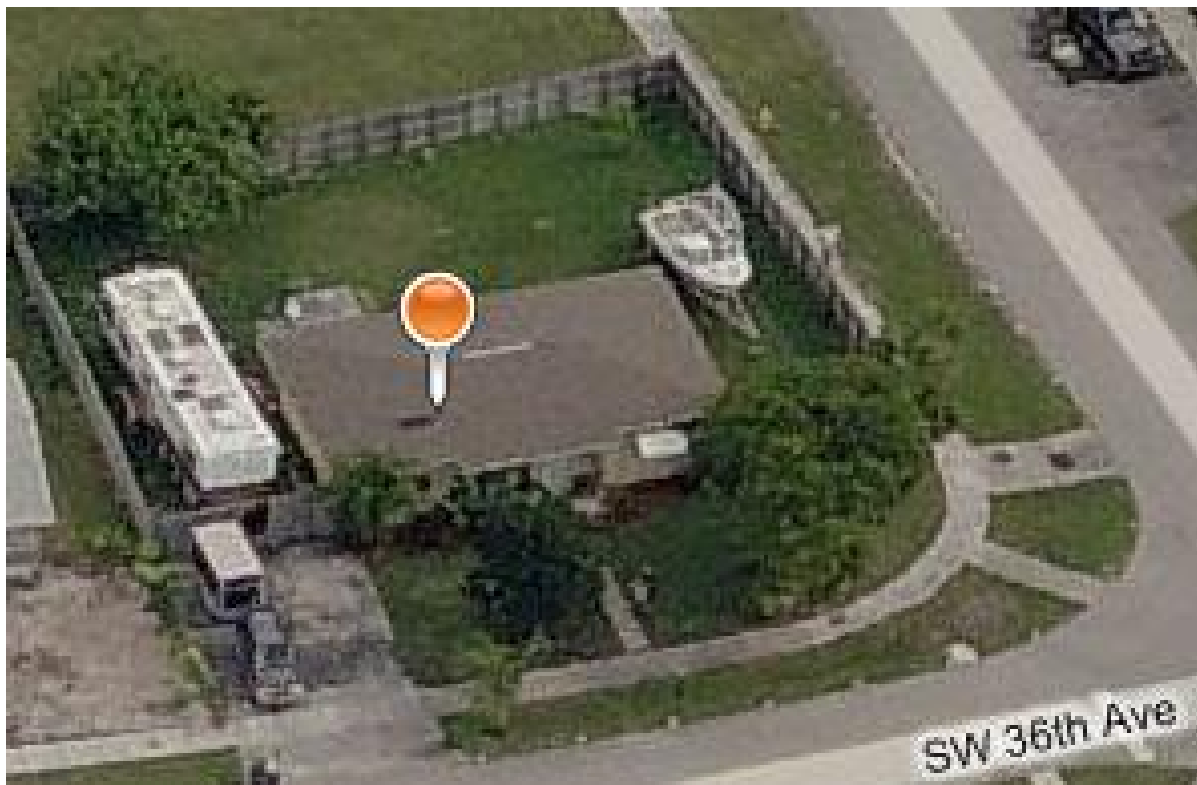
1. Roof Covering	Asphalt Shingle
2. Roof Age In Years	8 years
3. Last Updated	Feb 10, 2003
4. Life Expectancy In Years	12 years
5. Replaced	Full Replacement
6. Signs of Damage?	No
7. Signs of Leaks?	No
8. Comments	Overall condition looked good. No signs of any leaks. Several roof repairs have been done.
